RE: Arlington Parks Playground Assessment and Recommendation Report

PLAYGROUND ASSESSMENT AND RECOMMENDATION REPORT

PLAYGROUND NAME & ADDRESS: Buzzell Field, 29 Summer Street

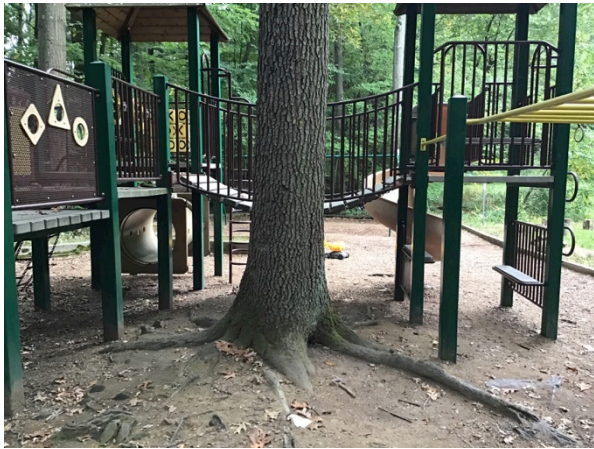
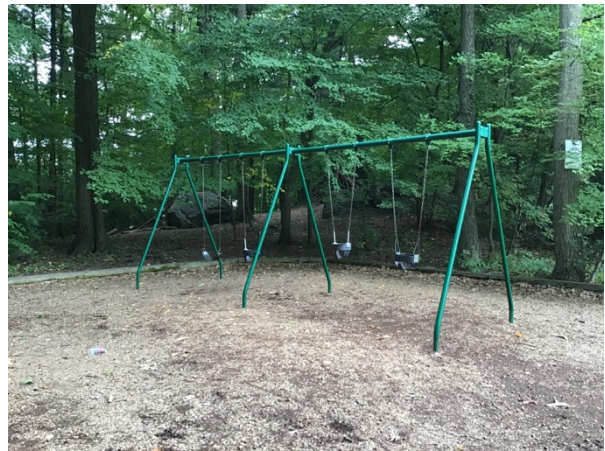
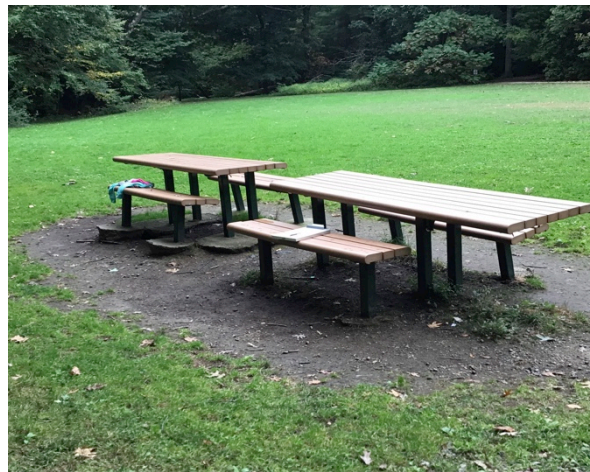
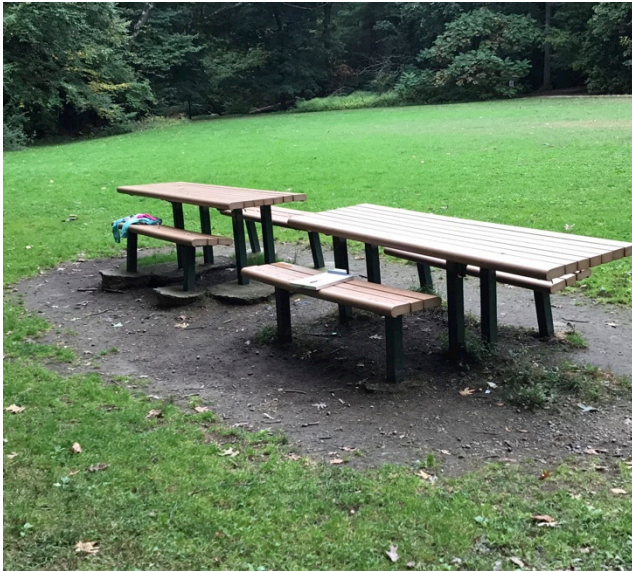
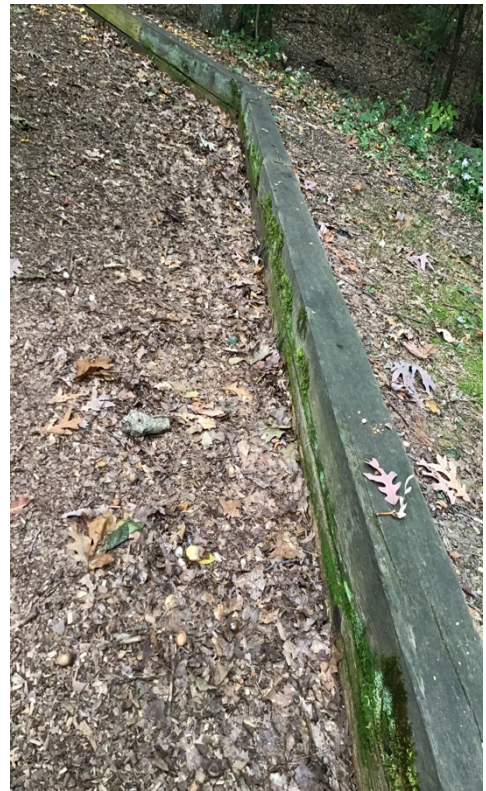
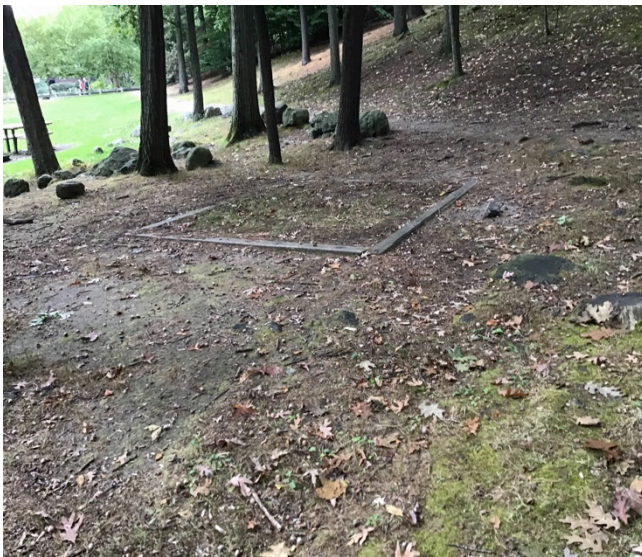
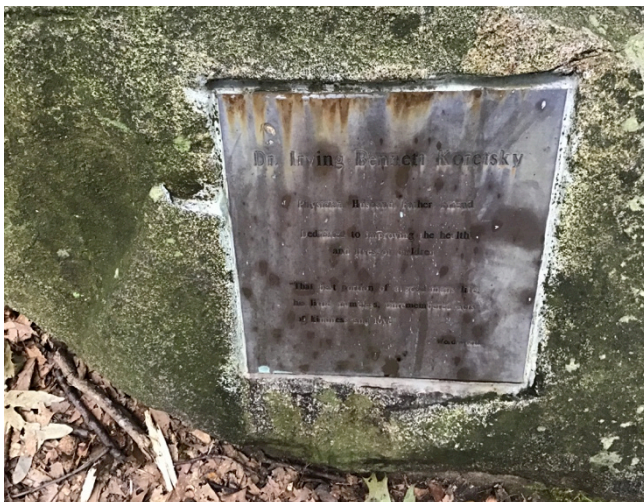
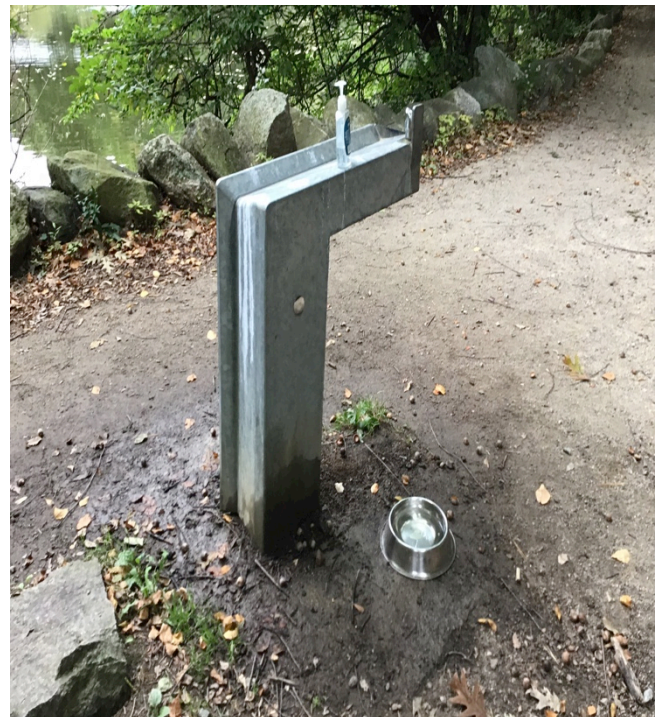
The surface is in poor condition, both in the playground area and in and around the picnic tables. The edging used to retaining surfacing is in poor condition. Animal feces, bagged and unbagged, were in and around the surfacing.

The Manufacturer of this playground is no longer in business. Much of the playground does not comply to current standards. A large tree has grown in the middle of the playground. The playground is age appropriate for 5-12 years, except for the swings – being appropriate for 2 – 12 years. In my professional opinion, there is no value in retaining this playground, it is dangerous, and is in very poor condition.

The swings are out of compliance due to inadequate use zone, hardware and chain status. The hardware cannot be retrofitted. The vegetation next to the swings is overgrown.

- Remove all equipment.
- Remove all logs.
- Remove all site furnishings.
- Change out the existing drinking fountain and add a 'water bottle filler' type, ADA compliant, and also a dog 'drinking' bowl.
- If replaced, a good deal of site work will be needed. Consider the playground be closer to the entrance of the park.

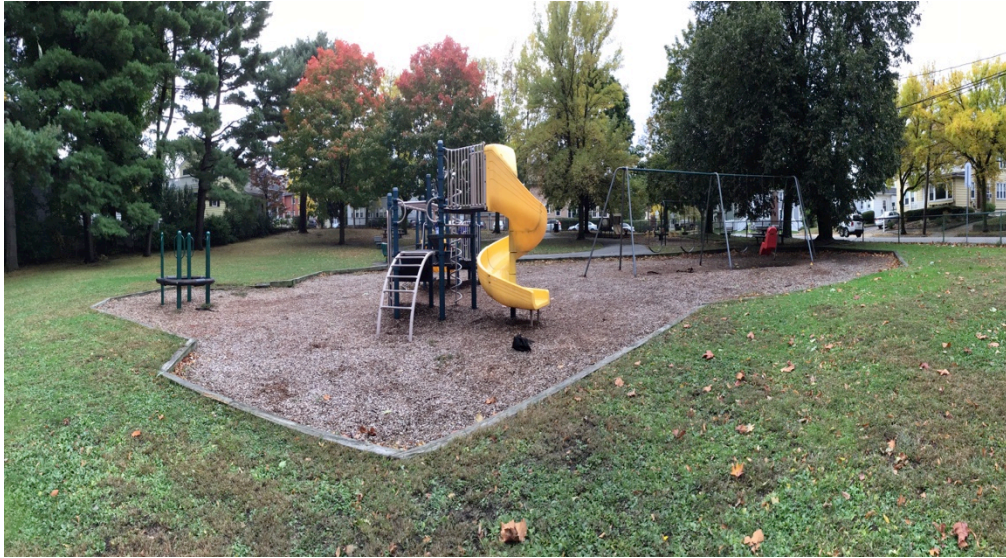
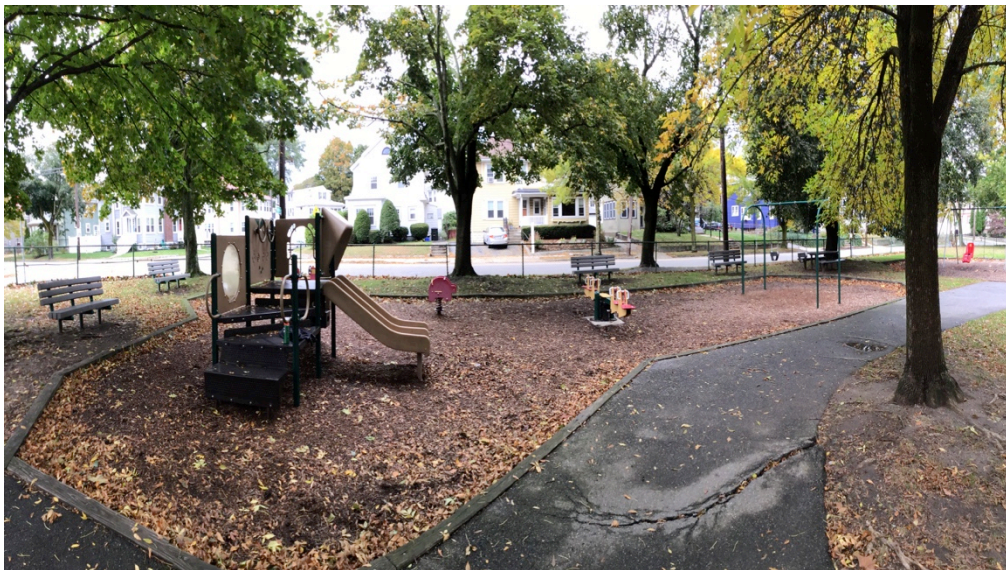
All swings need new hardware and chain. The belt seats needs to be replaced. The spring see saw is broken, and parts are no longer available; suggest to remove.

- Cut back trees to 84"
- Additional EWF needed [after vegetation clean up]
- Change out parts on the swings
- Smaller structure is in fair condition – suggest to retrofit
- Do not consider unitary surfacing material at this time.
- Remove the 5-12 structure and consider installing a unique independent piece/s of equipment. The space is open and this would enhance the value of the park.

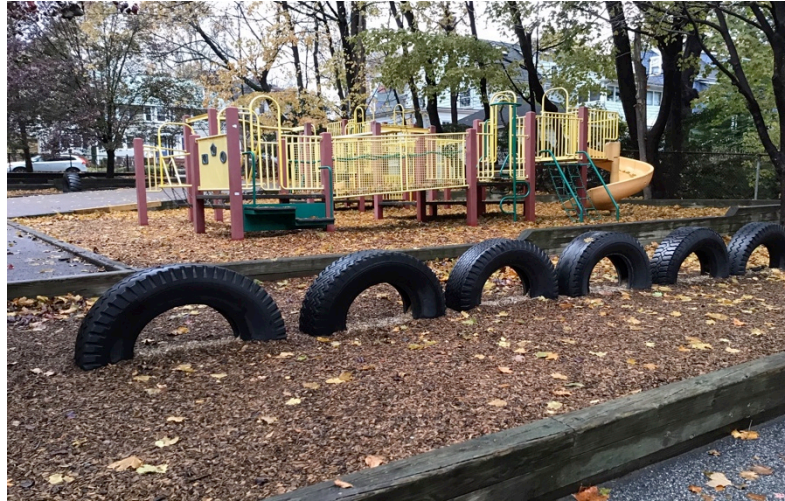
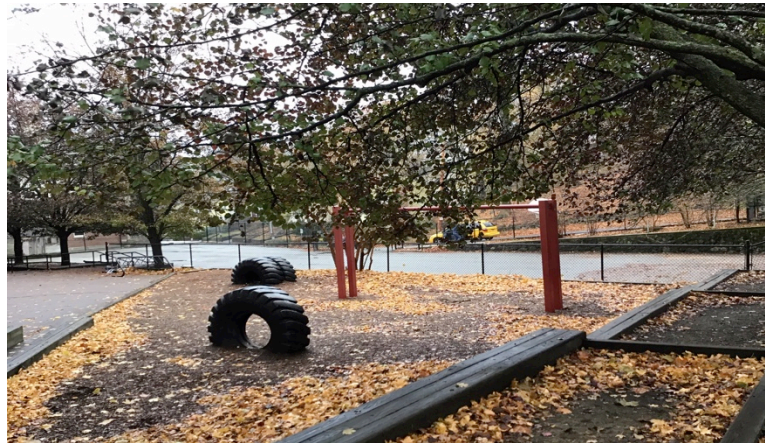
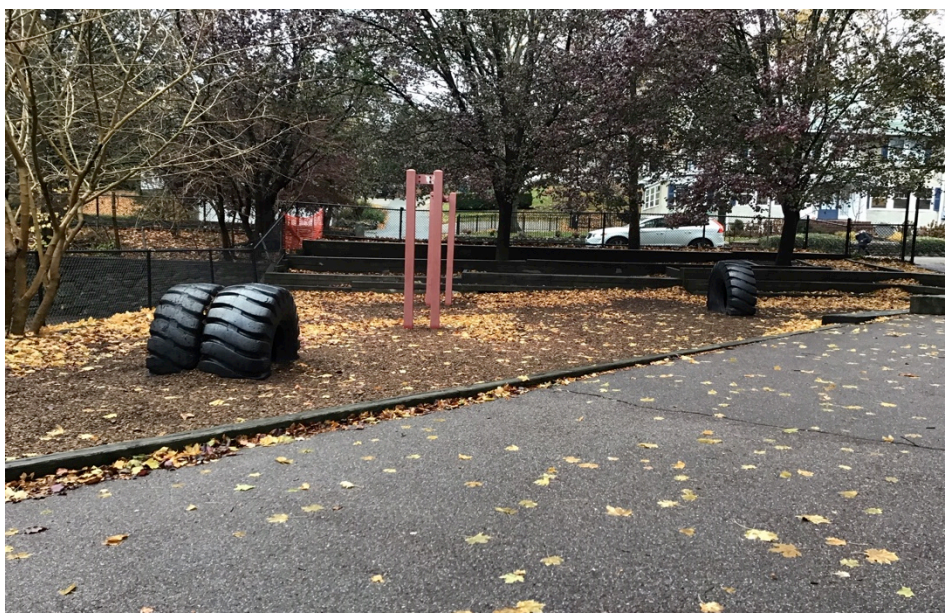
Remove the front spiral slide and board the top now. The slide is cracked and cannot be replaced, as the Manufacturer is no longer in business.

- Remove and replace the links.
- Cut back vegetation.
- If the school uses the playground, they should be aware that the equipment is in 'fair to poor' condition. Efforts may be made to repair the equipment as an interim step.
- If the school does not use the playground, a few independent pieces of equipment could be considered for the future.
- This playground could be on the priority list, but first, the user needs to be identified [school and/or neighborhood].
- If the Pre-K children are using this site, I recommend not allowing them to use the site, as it is not age appropriate.
- In my professional opinion, I suggest to remove and replace the swings with a 5-12 climbing net.

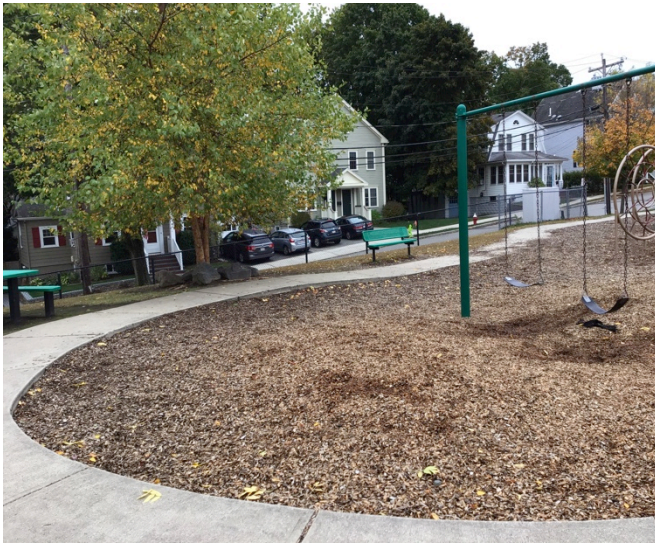
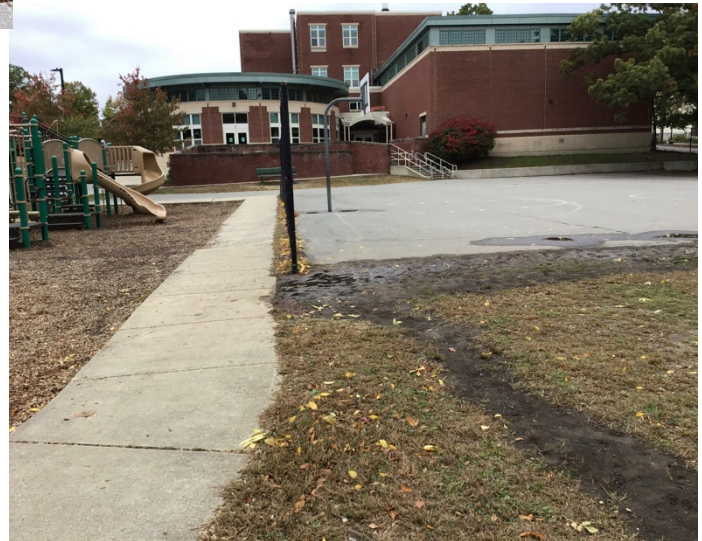
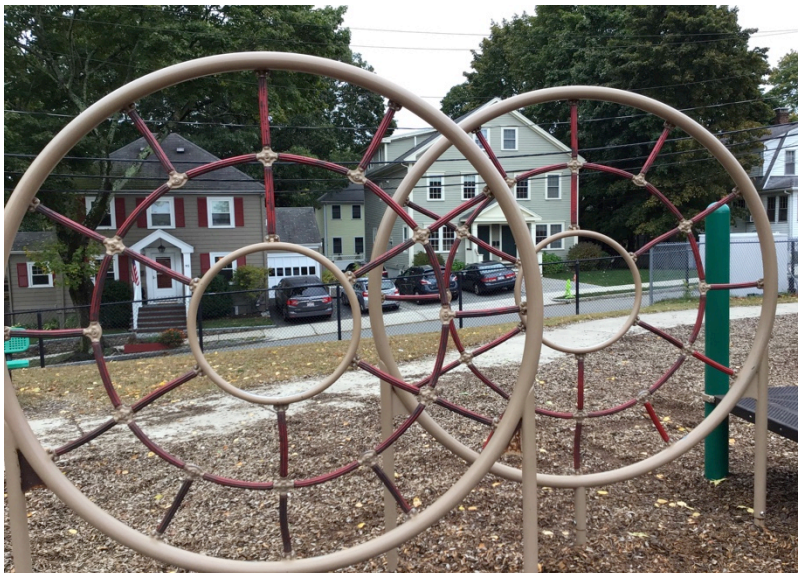
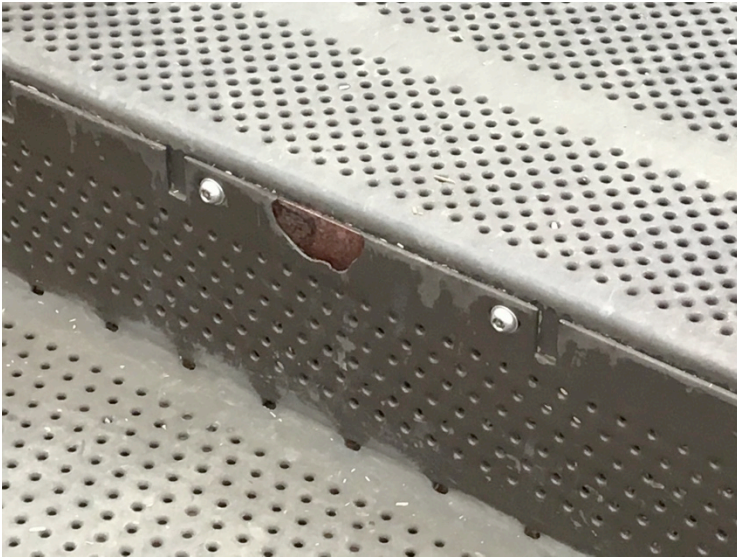
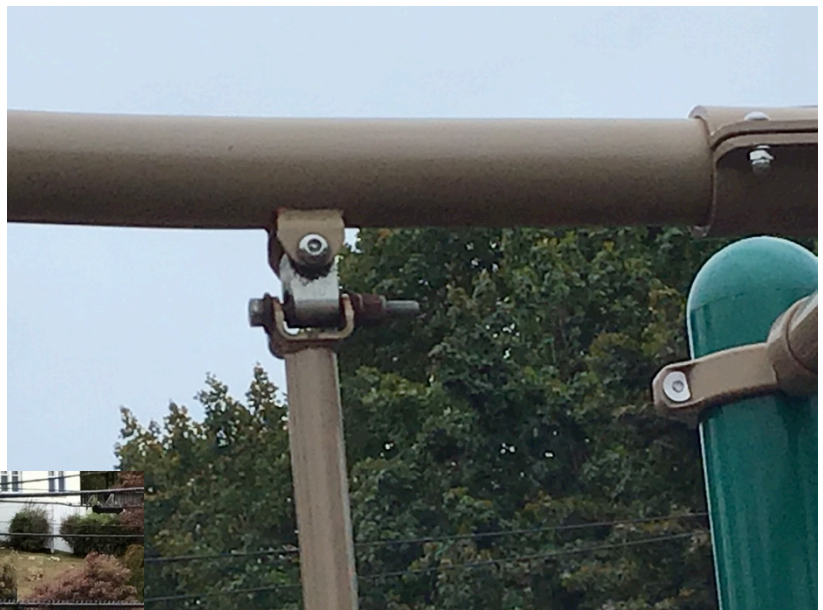
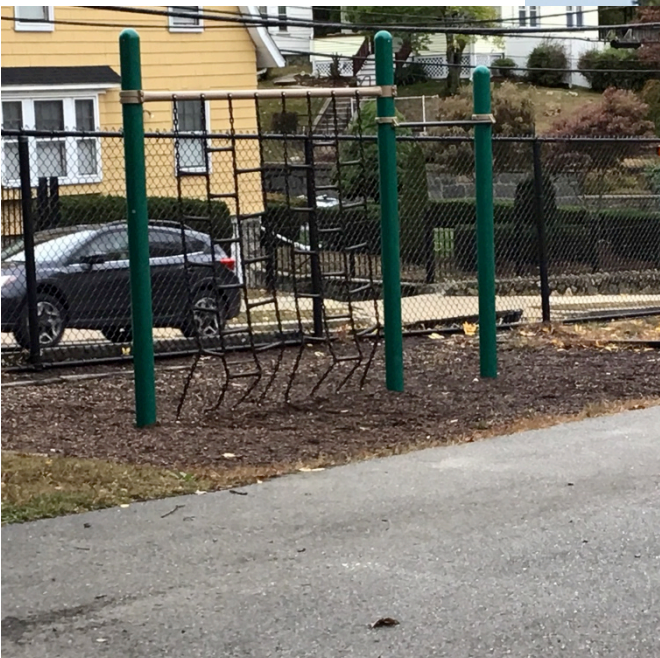
The surfacing is in fair condition. Weeding and a 'top off' of EWF is needed. The site has a good linear layout that prevents the splay and loss of EWF.

Swing hardware, cable and other moving parts need to be replaced now. It is cost effective to put this structure back into service – which will allow several more years of use. Additional benches are recommended.

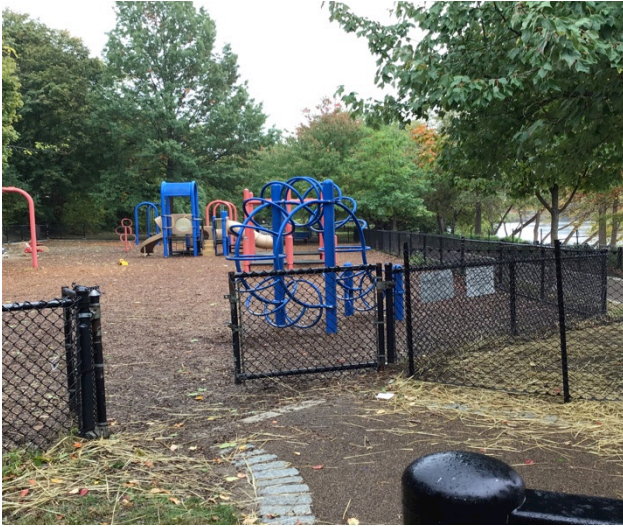
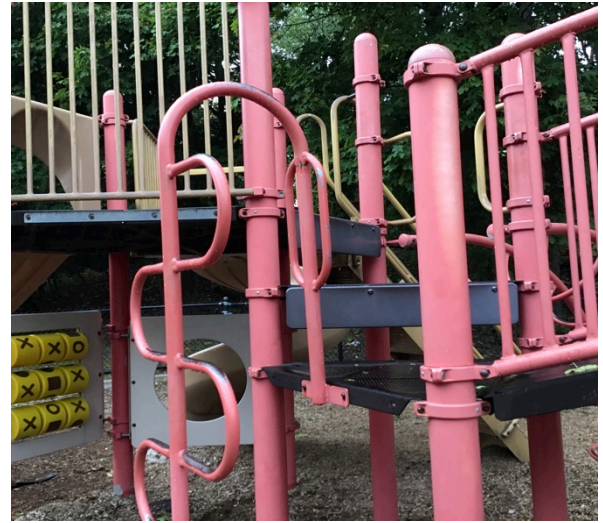
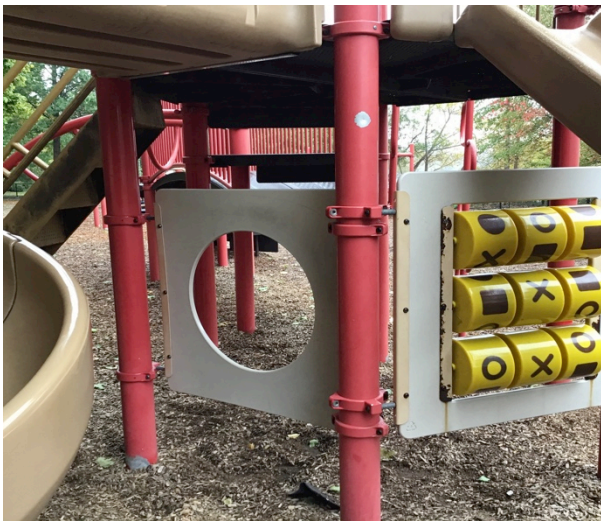
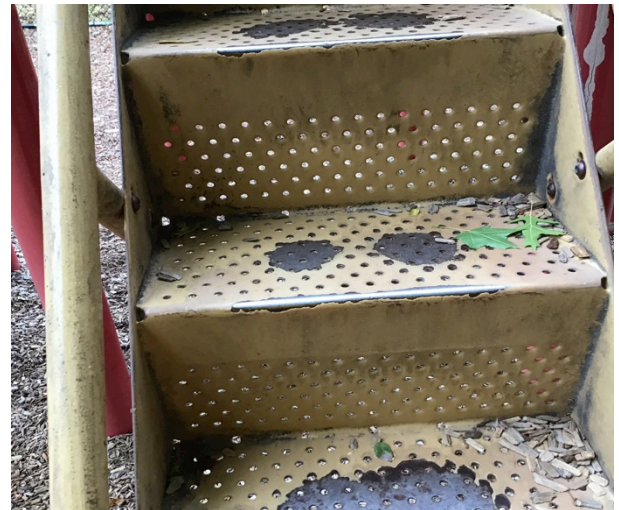
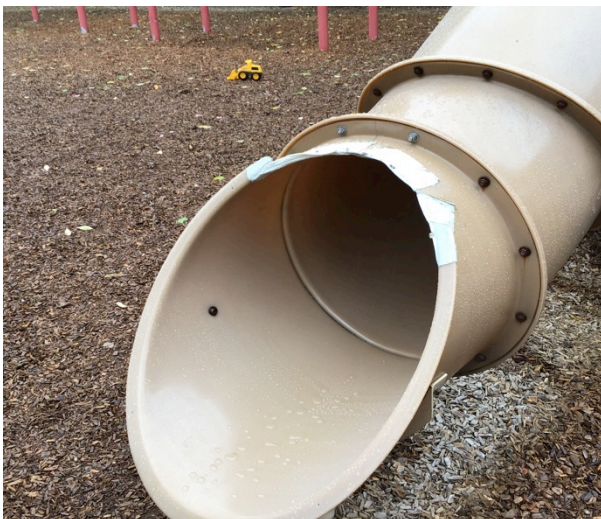
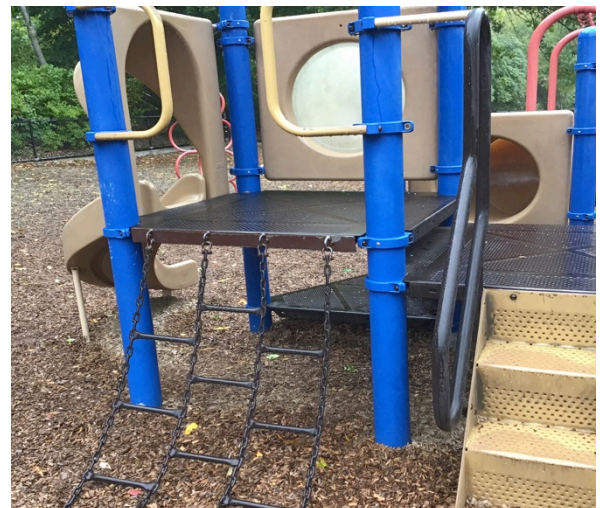
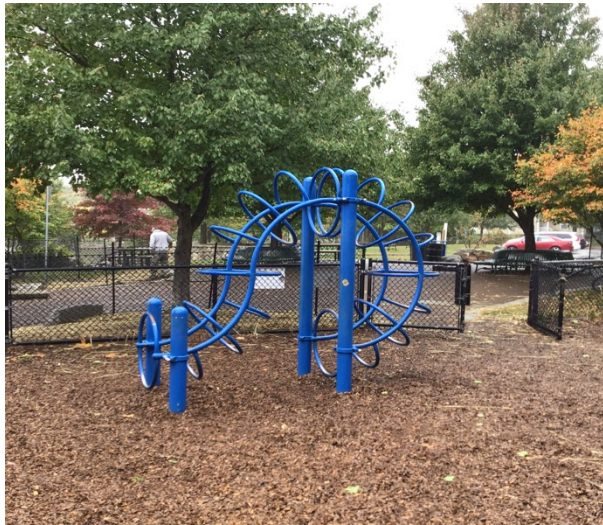
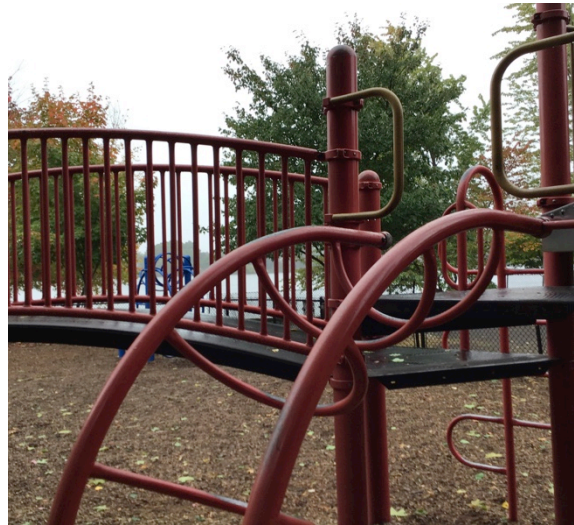
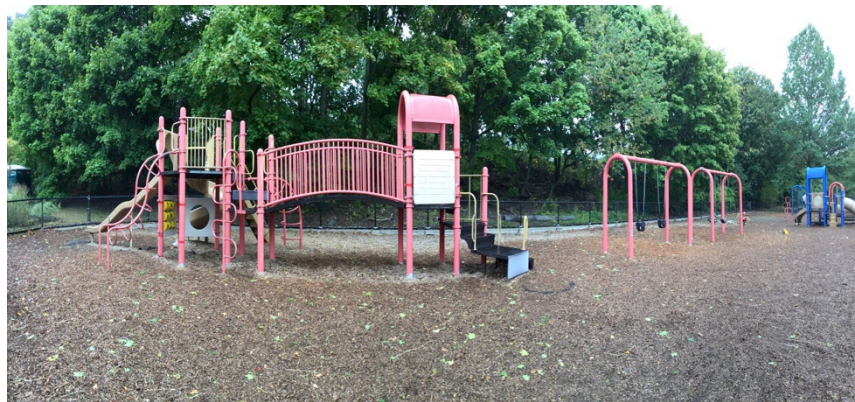
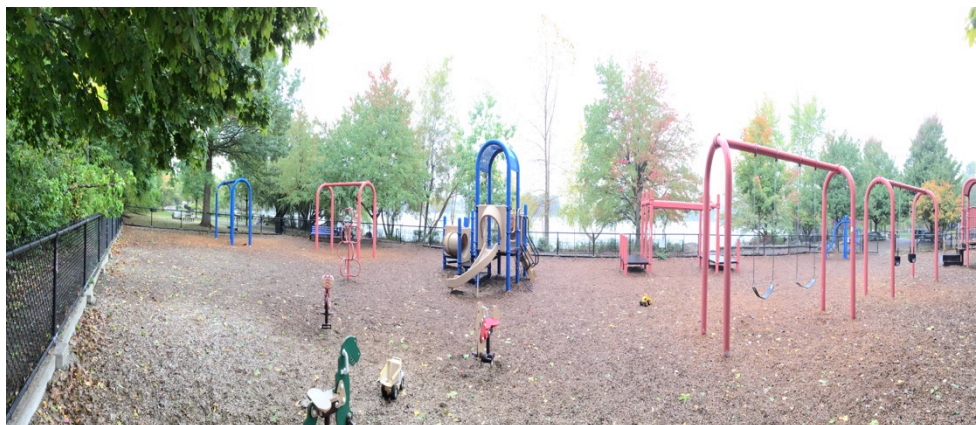
ADDITIONAL PLAYGROUND PHOTOS

The swings and spring riders are in good condition. All other individual equipment is in poor condition. The swings could be repurposed now, but with a new layout and playground they should be disposed.

- The structures are well beyond their years of use and should be removed sooner rather than later. They are in very poor condition.
- The independent circle climbers should be removed now.
- In my professional opinion, I recommend a full restoration and the removal of the spring riders for future use at the new play area or reinstalled at another site.
- PIP should be considered for the entire interior and is well suited for Spy Pond Park.
- Design of the playground should have surfacing in the forefront, as the cost will be more than the equipment.
- The park rehabilitation will increase overall use and it is important that this playground be at the top of the priority list.

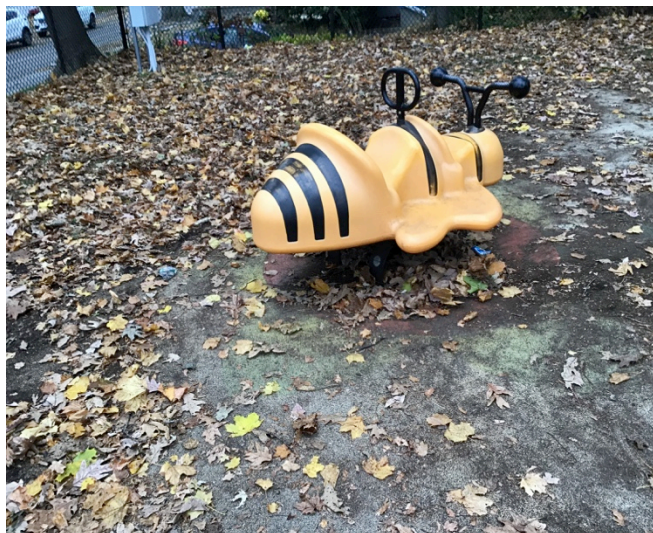
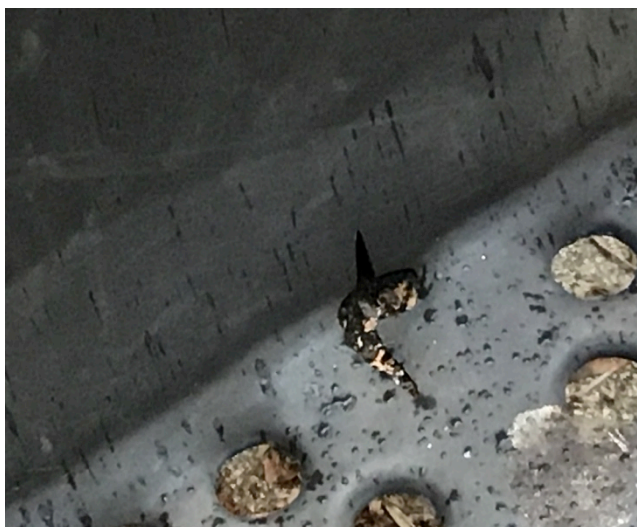
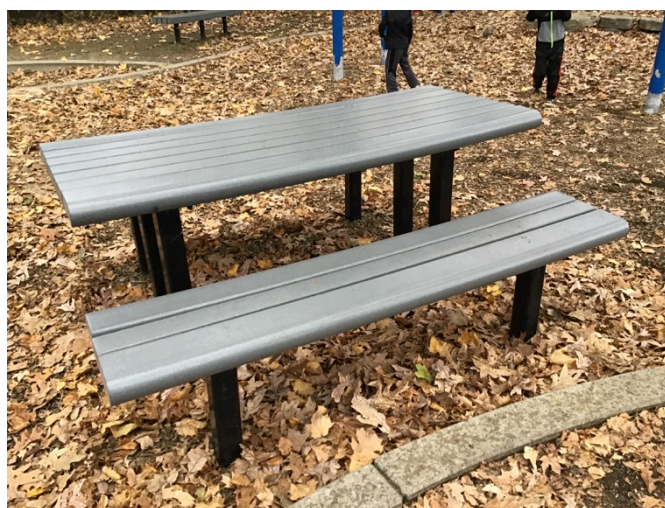
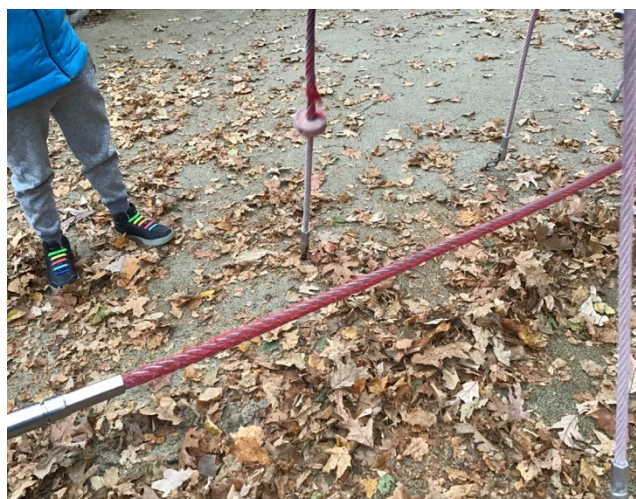
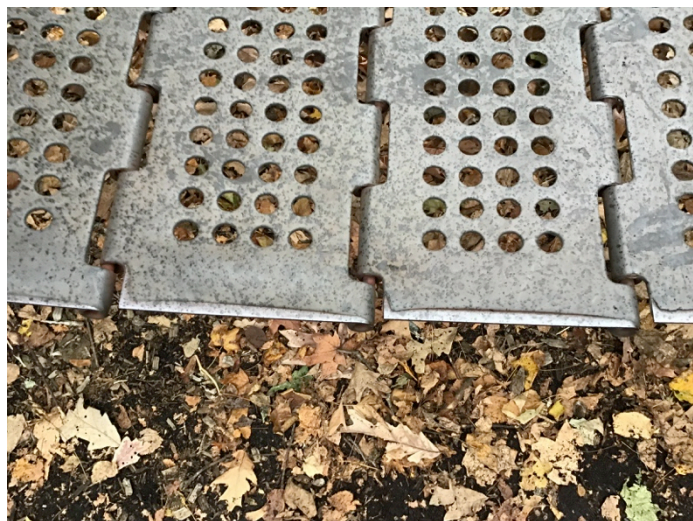
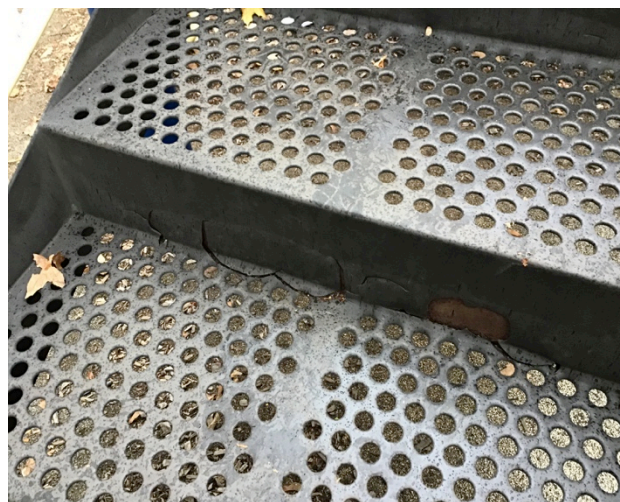
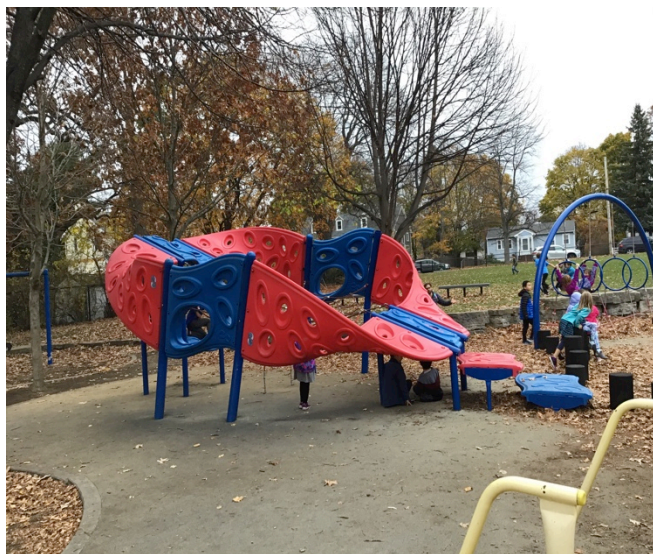
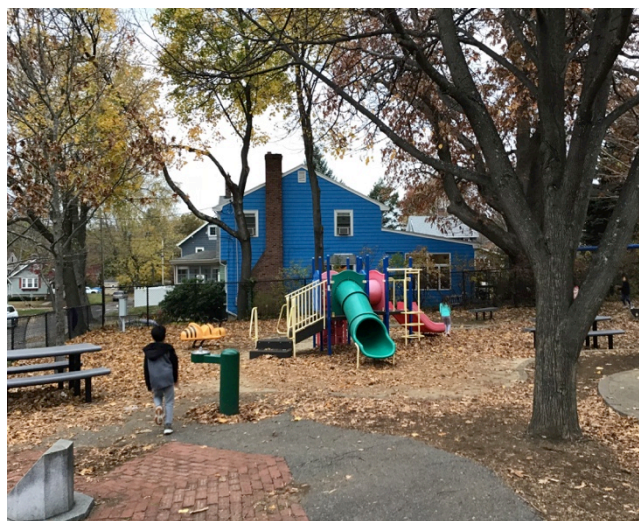
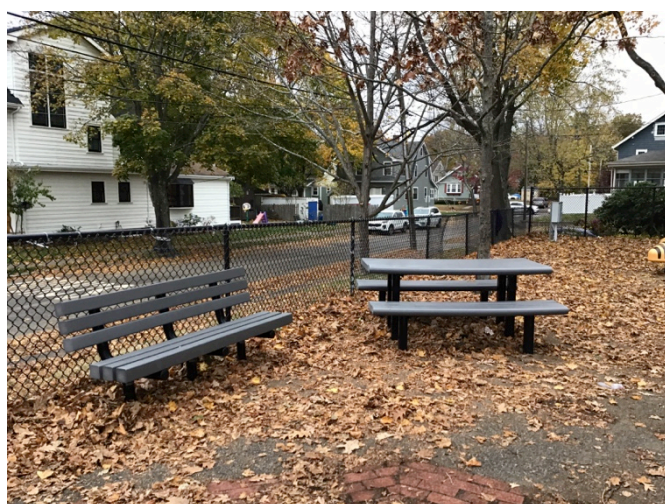
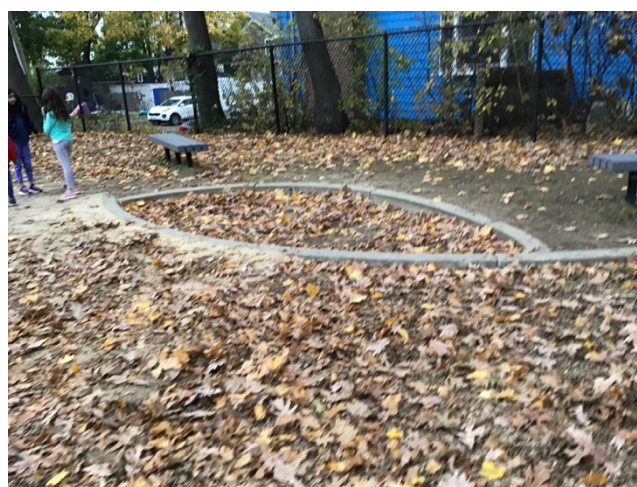
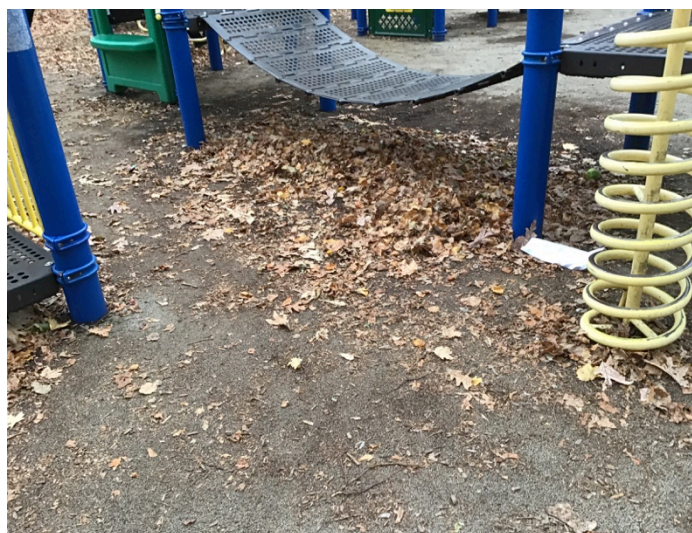
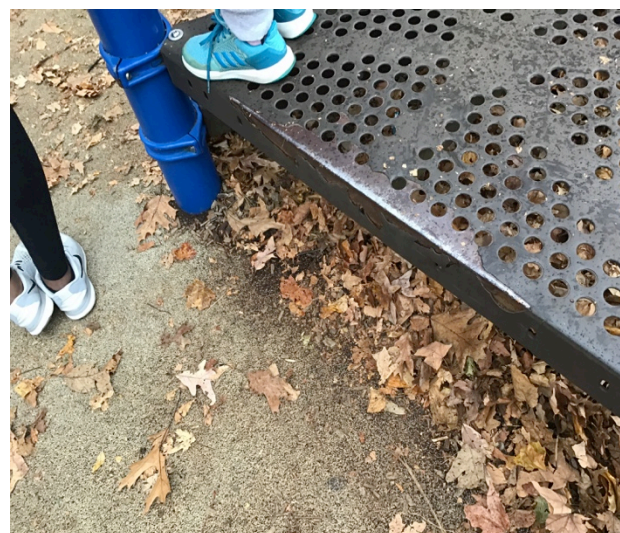
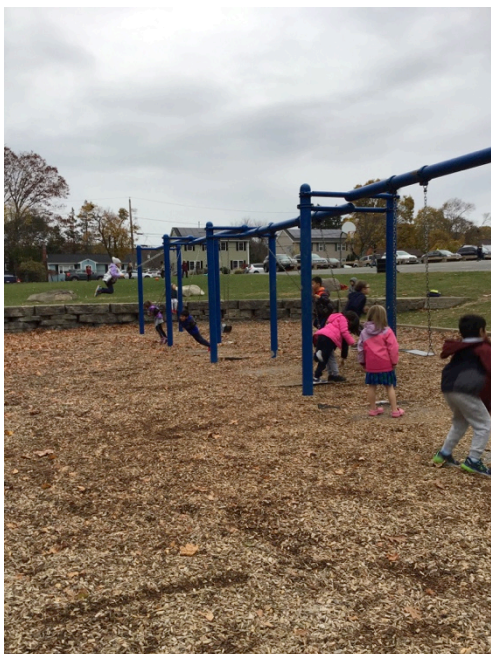
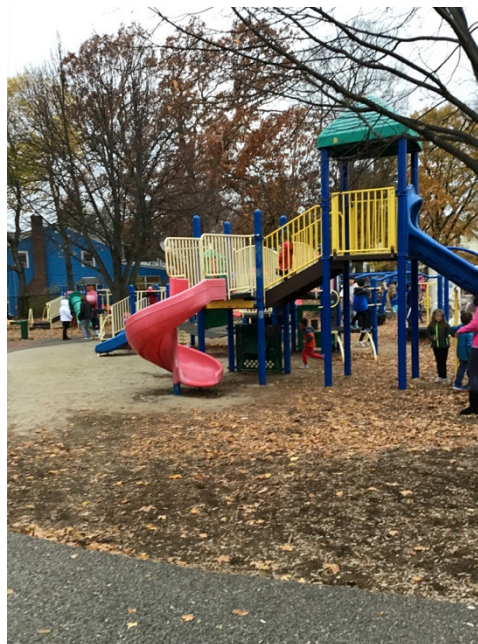
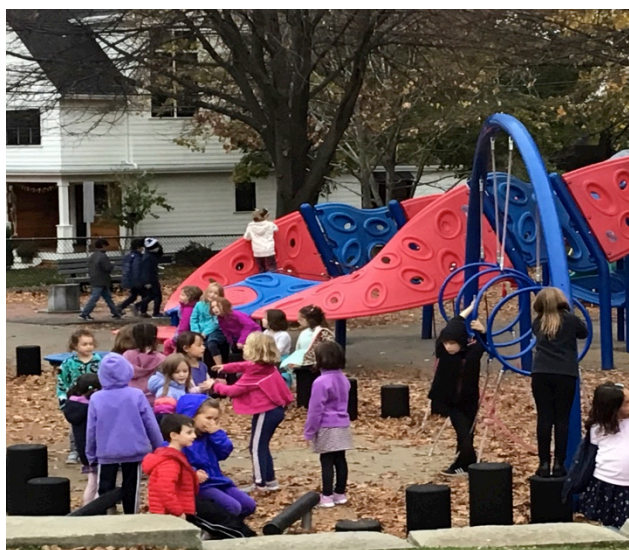
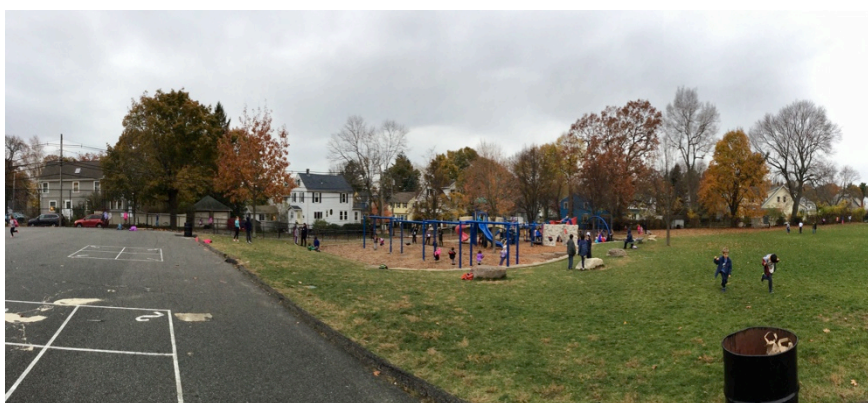
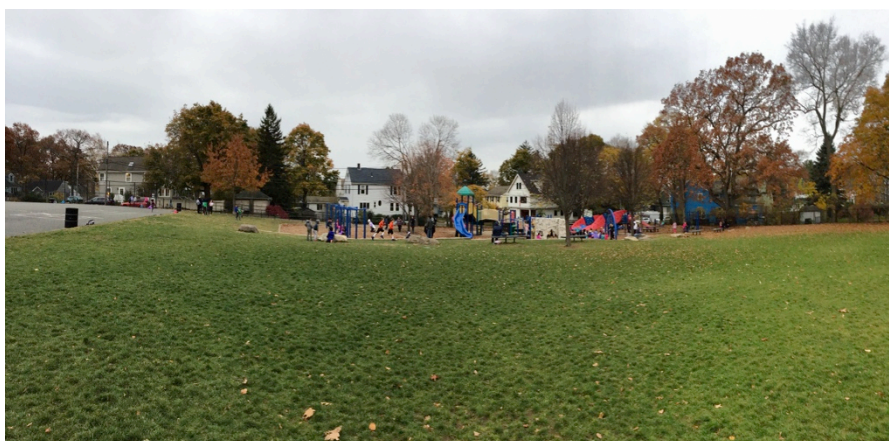
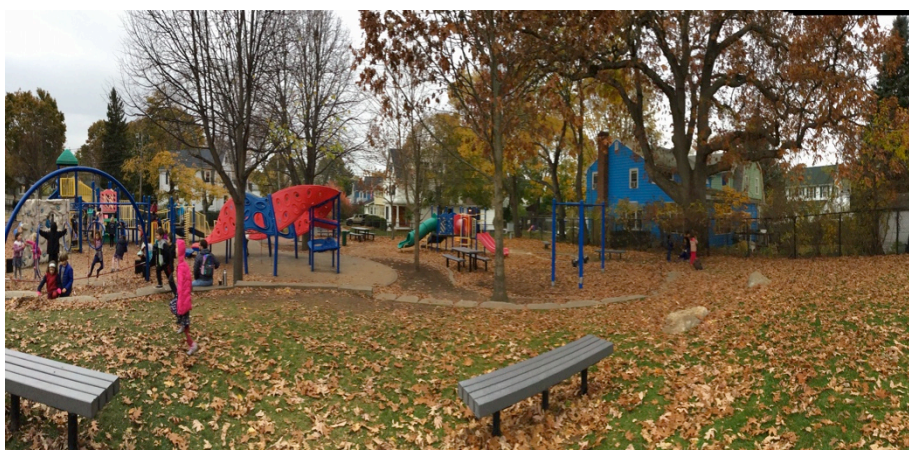
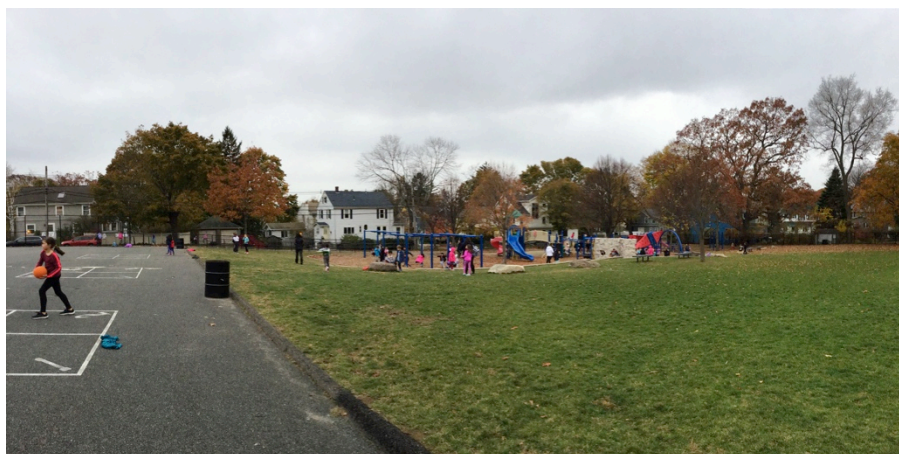
ADDITIONAL PLAYGROUND PHOTOS

The structure for 5-12 connects to independent pieces (continuous play). The connecting decks, stairs and bridges are worn and rusting and need to be replacement. The 2-5 structure is in better condition due to less use. Site lines are impaired – as I could not see the 2-5 area through the 5-12 area.

There is a bee spring rider in good condition. The swing frames are in good condition. Swing hardware should be replaced.

- Consider new decks and bridges. PIP surfacing will not have to be disturbed, as decks are above ground. This will be a 'short term fix', but heavy use is taking its toll on the decks and bridges.
- Remove leaves and power wash the structure and PIP surfacing.
- Replace and purchase new rope for rope walk.
- This playground should be amongst the first to be rehabilitated. If repairs and investments are made now, the site should last for several more years.
- Park and Recreation playgrounds that are also used by schools, need additional maintenance. The playground needs to be maintained on a monthly basis, at least.
- For future planning, the swings and the 2-5 structure should be installed differently. The swings should be located closer to the back, and the 2-5 closer to the front.
- The slope of the land may lend itself to an embankment slide.

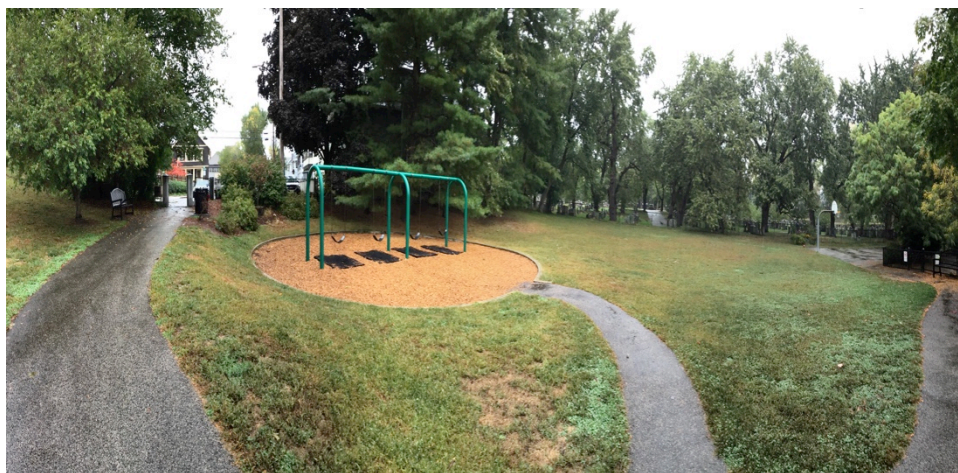
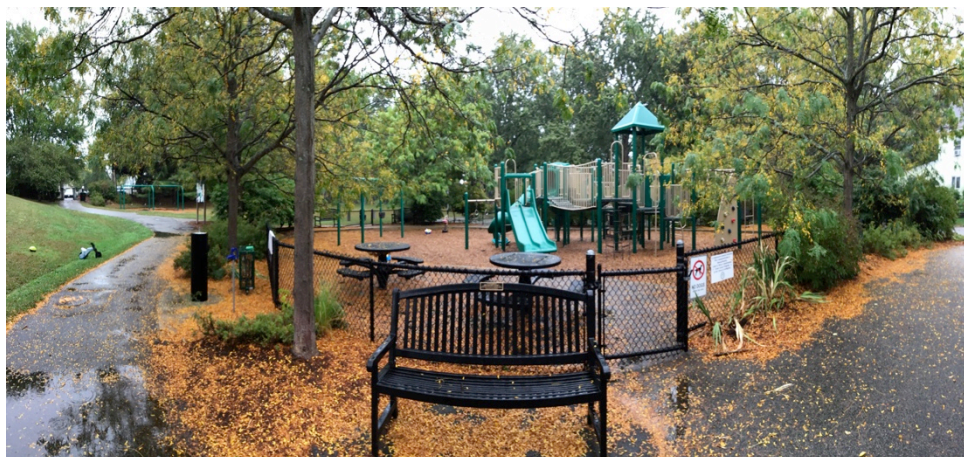
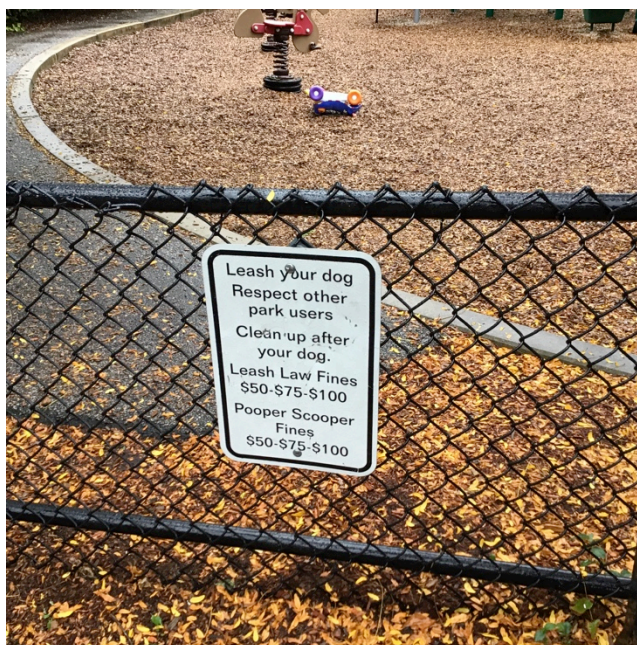
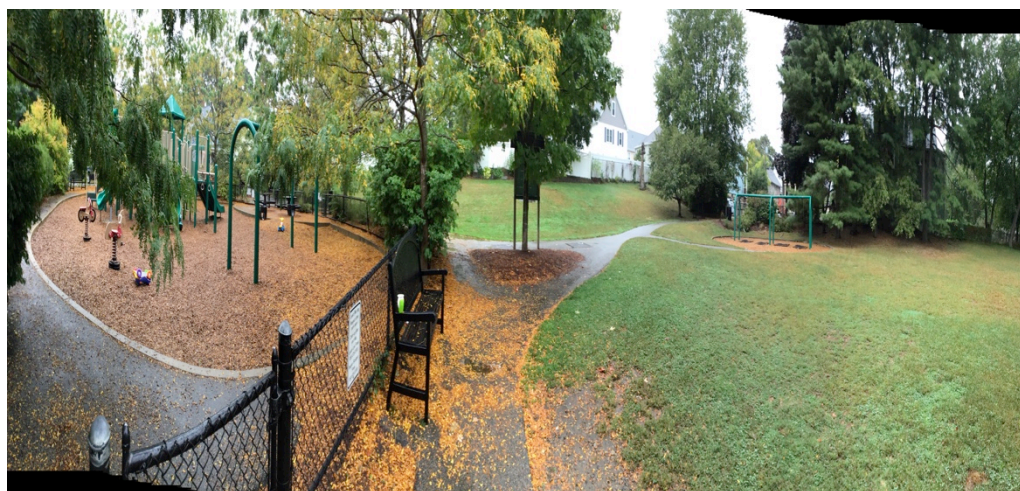
ADDITIONAL PLAYGROUND PHOTOS

The surface is EWF – additional EWF is needed in both structure and swing area. There are wear pads by the belt swings.

This structure is in good condition. Replace the 'burned' store panel now. The one structure is age appropriate for age 5-12 years, but spring riders are appropriate for 2-5 years. If the largest user base is 2-

The swing beams are in good conditions, but all hardware is in fair condition.

The belt swings could benefit by unitary surfacing at least to one seat [asphalt is intact]. There is poor visibility from the enclosed play area to the belt swing – due to poor placement of equipment. The site furnishings are in good condition.

- The chain ladder on the structure needs to be replaced [Gametime].
- Consider replacing the burned store panel.
- Retain equipment, as it is in good condition, and install unitary material now. The interior of the fence is a small footprint, thus making unitary material easy/ier to install.
- Add unitary material to the first swing seat closest to the sidewalk, and change one belt seat to an adaptive seat.
- Switch placement of the picnic tables and bench. As the playground has a fence, an area to eat food items should be segregated from the play area [ie: play inside the fence; eat outside the fence].

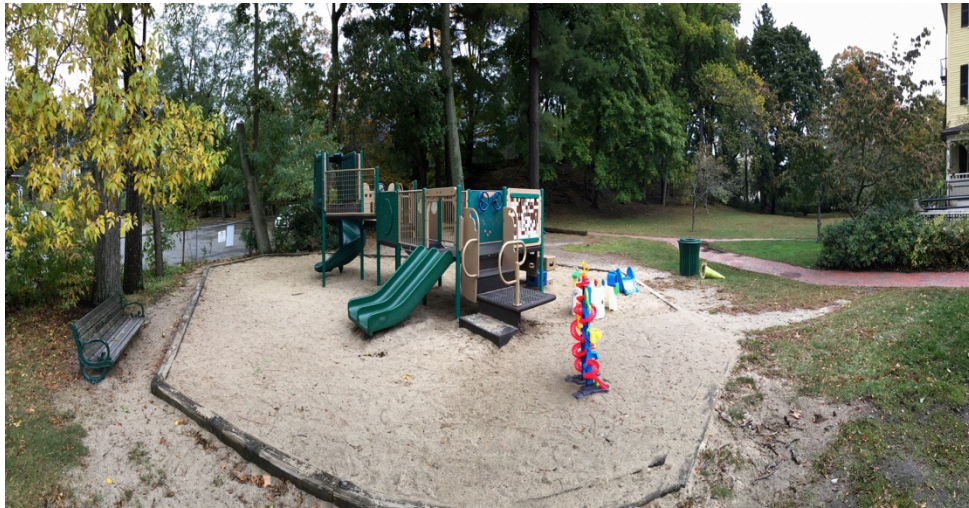
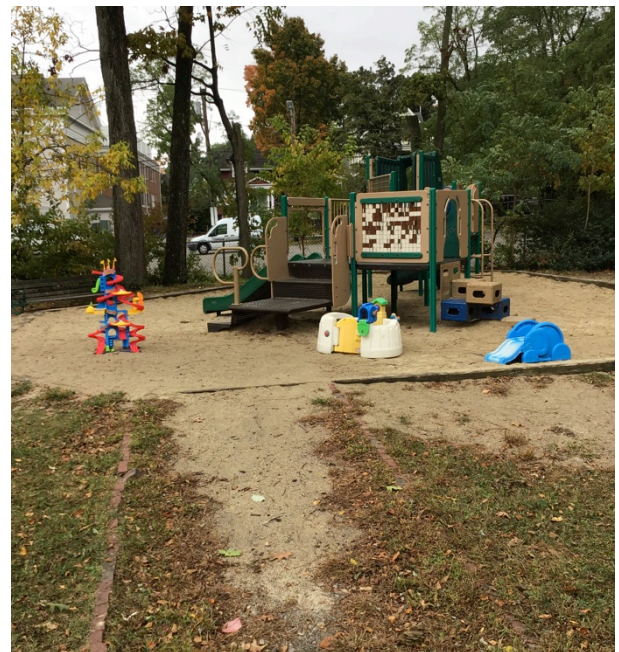
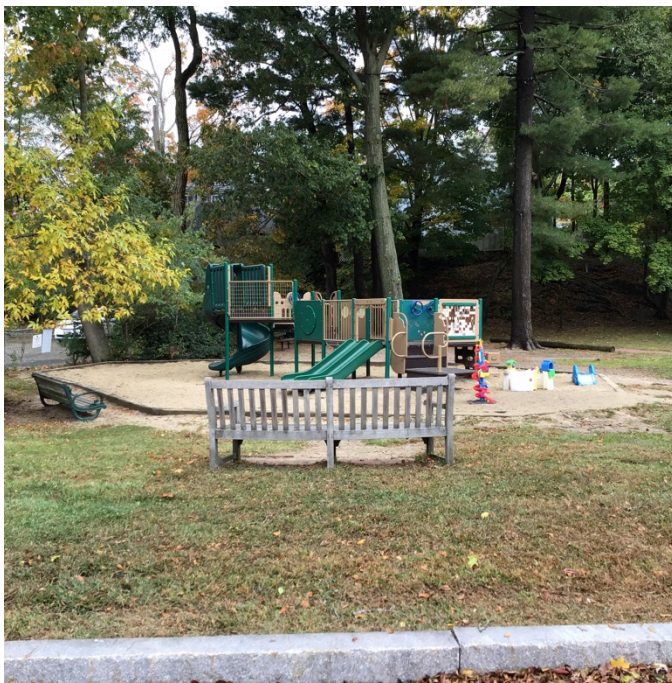
ADDITIONAL PLAYGROUND PHOTOS

The surfacing is sand. All the sand should be removed and replaced for health reasons. Consider using EWF. Access is good from the parking lot, but not when you reach the play area. If 'grass mats' are added to the surfacing, it will meet ADA and MAAB for handicap accessibility. The mats could 'go over' the sand, and then be 'topped off' with more sand.

The structure is in very good condition. Consider power washing, as there is 'ground in' dirt and sand. The grit produced by the sand, shortens the structures life.

Signage is needed to define the parking space [and its ownership].
